## THE CHANGE OF THE DYNAMIC CHARACTERISTICS USING MICROTREMOR

Tsutomu Sato<sup>1</sup>, Yutaka Nakamura<sup>1,2</sup>, Jun Saita<sup>1</sup>

<sup>1</sup> System and Data Research Co., Ltd., Tokyo, Japan

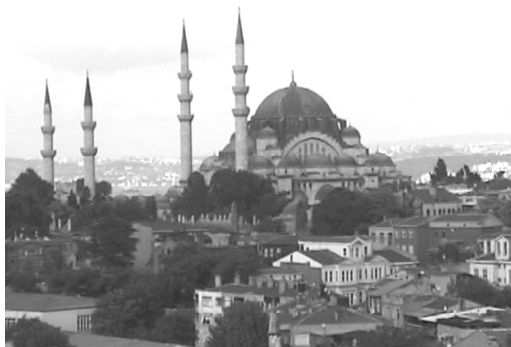
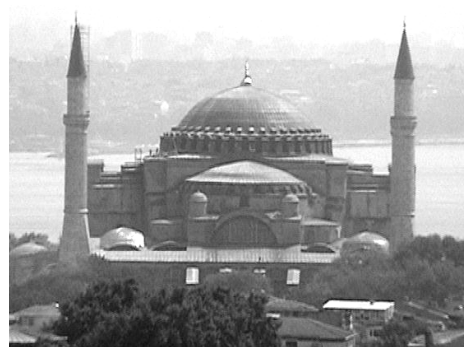
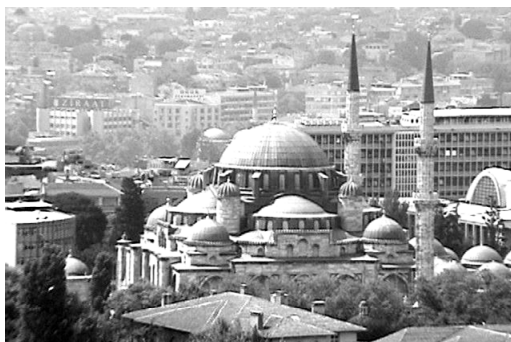
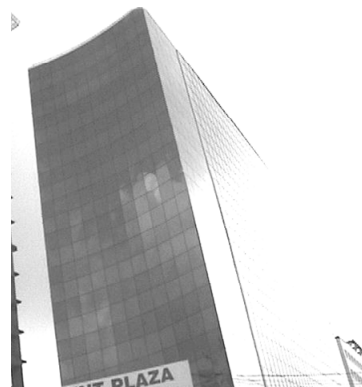
Figure 1. Overview of Measured Structures

Microtremor measurement was conducted for historical structures as Suleymaniye mosque, Hagia Sophia museum, Sehzade mosque, and newly constructed office building. Figure 1 shows the overview of these structures. Figures 2 to 5 show the floor plan and elevation with measurement points, and Table 1 shows the detail of the structures such as height, structural type, established year and the date of measurement.

(a) Suleymaniye Mosque

(b) Hagia Sophia Museum

(c) Sehzade Mosque

(d) An Office Building

Measured historical structures have a main dome supported by four arches on four big piers. In case of Suleymaniye mosque and Hagia Sophia museum, a pair of opposite arches are reinforced by two semi-domes. In case of Hagia Sophia museum with a main dome of diameter of 31 m, the spaces beneath the arches are filled as a wall and the dome appears as though it is supported by the walls instead of arches. The internal space is 30 m width x 80 m length. The main dome has been partially affected by earthquakes several times and was restored each time. On the whole, the structure has deteriorated considerably and a certain countermeasure has been required.

The basement grounds for historical structures mentioned above are firm and are in good condition. An Office Building made by Reinforced Concrete (RC) structure is a 14-story building with 5 underground levels and will be used for shopping centers and business offices. Each floor has the 57 m x 16 m rectangular section, and in the central part of the south side, facilities of utility such as elevators, stairs and etc. are equipped. This building was constructed on the firm ground, and is situated near the YPK station, which recorded maximum acceleration 41Gal at the time of the Kocaeli earthquake.

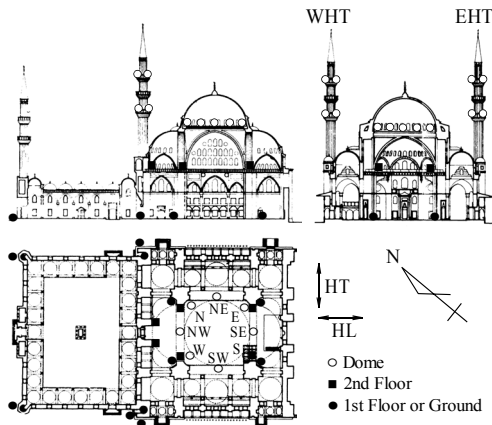
Figure 2. The elevation and floor plan with measurement points in Suleymaniye mosque. (○,■,●:Measurement points)

About minaret, two minarets of both Suleymaniye and Sehzade mosque were measured. Suleymaniye mosque has two high minarets and two low minarets. High minarets (WHT and EHT) were measured at the highest and lowest balcony of three balconies. Every balcony has four measurement points and a pair of them was measured simultaneously. On the EHT minaret, however, only s-side point of highest balcony was measured because of the failure of instrument at the time of before the earthquake.

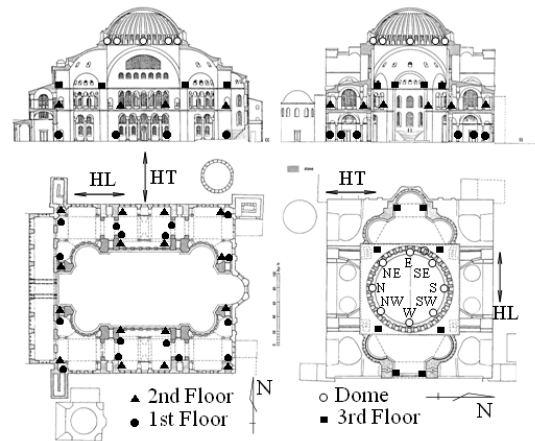
Figure 3. The elevation and floor plan with measurement points in Hagia Sophia museum. (○,●,▲,■:Measurement points)

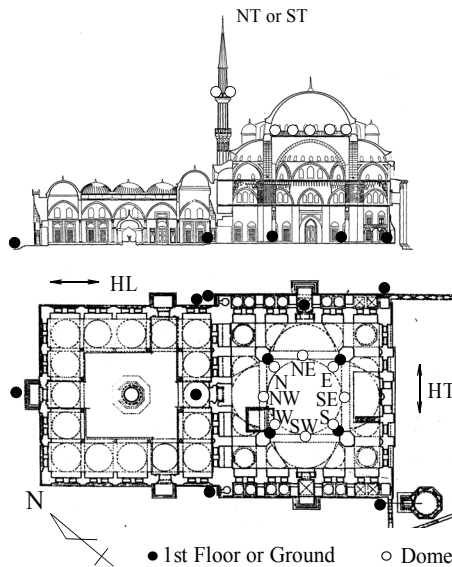
Figure 4. The elevation and floor plan with measurement points in Sehzade mosque. (○,●:Measurement points)

Sehzade mosque has two minarets with two balconies each other. Measurement was conducted at four measurement points only on the upper balcony. Moreover, for the base ground, measurement points were situated around the structure.

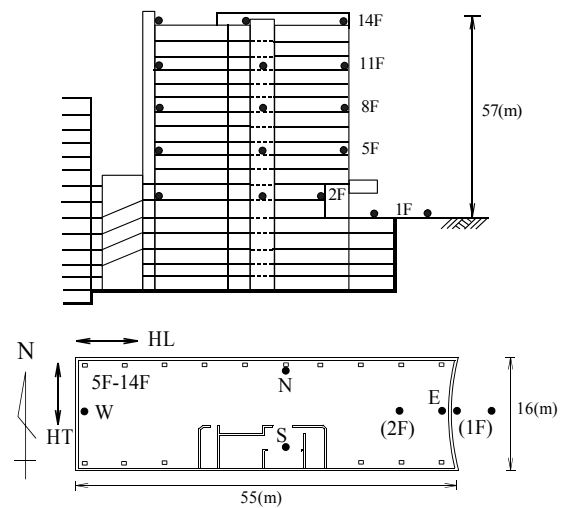
Figure 5. The elevation and floor plan with measurement points in a newly constructed office building. (●:Measurement points)

In case of the office building, on the vibration of NS component, the shift of predominant frequency correspond to less than 1  $\Delta F$  and is not considered a significant change. Considering that the floor shape of this building is flat and extremely short in the NS component as shown in Figure 5, its rocking vibration excels in vibration of the NS direction. And it is thought that the rigidity of a base is more strongly reflected rather than the rigidity of a building itself. The fact that the natural frequency of the NS component did not change before and after the earthquake suggests that the earthquake did not influenced the base at all.

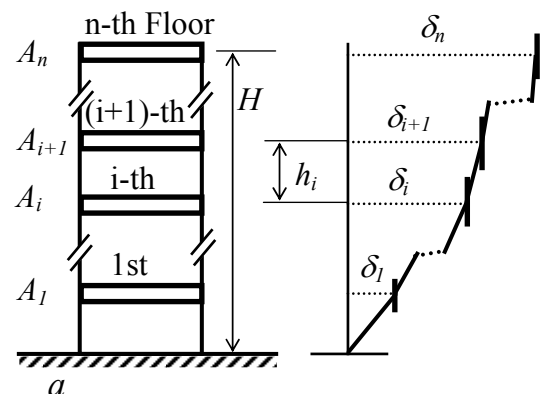
Figure 6. Schematic model of n-th floor structures and its mode shape.  $\delta_i$  is the horizontal displacement,  $h_i$  is the height,  $A_i$  is amplification factor of i-th story column,  $H$  is the height of the n-th floor structure, and  $a$  is the horizontal acceleration of foundation ground.

frequency of the structure that seems to have influence on earthquake damage is considered. Displacement  $\delta_i$  of  $i$ -th floor is estimated from this primary natural frequency  $F$  and amplitude  $A_i$  of  $i$ -th floor as followings (See figure 6).

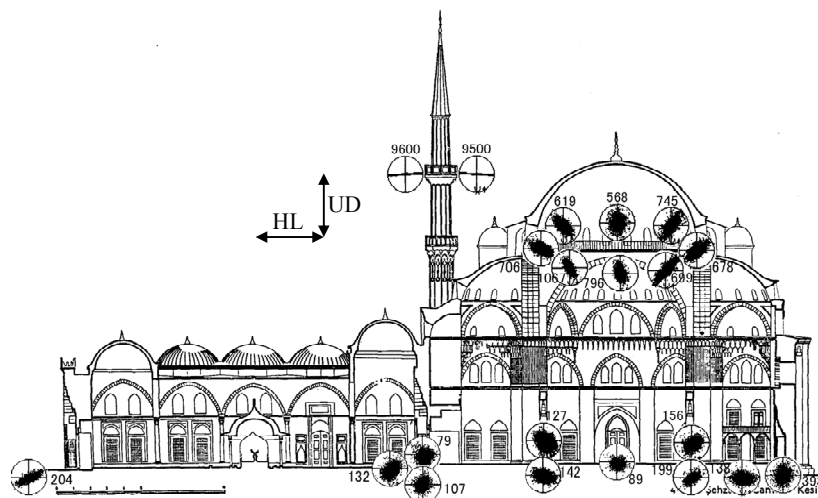
Figure 7. Normalized Loci of Microtremors in HL-UD Plane for 40.96 second at each Measurement Points of Sehzade Mosque (non-simultaneous measurement). Dots in circle indicate the normalized locus, and the number near the circle means maximum value of microtremor in unit of  $10^{-8}$  m/s.

the locus of microtremor for 40.96 seconds in the circle to the position corresponding to every measurement point, and the number near the circle means maximum amplitude in  $10^{-8}$  m/s. This figure shows that minarets are vibrating more intensely than the structures. The state of the vibration for main dome can also be grasped by this figure.

Figure 7 shows the velocity loci of microtremor at every measurement point on Sehzade mosque. It shows

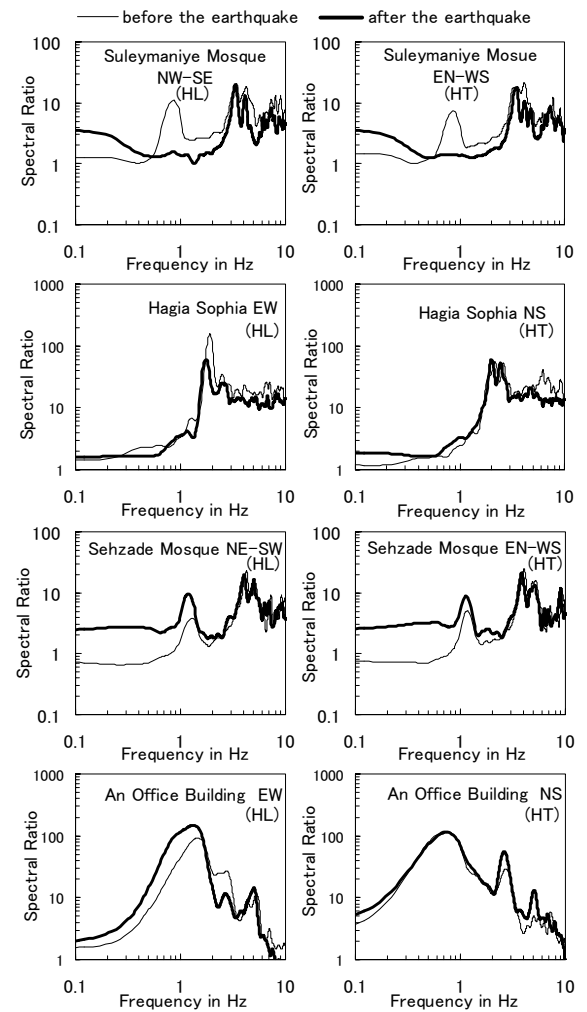
Figure 8 shows the transfer functions of four structures before and after the earthquake estimated from the result of microtremor measurement. Figure 9 shows examples of the transfer functions for minarets.

Figure 8. Estimated transfer functions of the highest floor of structures.

In case of Suleymaniye mosque, the peak frequency near 0.8 Hz is significant on the corridor of the main dome (DM) only before the earthquake. And in case of Sehzade mosque, the peak amplification factor near 1.2 Hz increased after the earthquake. These peak frequencies may correspond to the peak frequencies of minarets. Tables 2 to 5 shows the shift of the natural frequencies and amplification factor of the estimated transfer functions before and after the earthquake for both horizontal components and torsion component, except the peak frequencies mentioned above. Measurement before the earthquake of a Suleymaniye mosque was performed in two days on alternate days. The day WHT minaret was measured was not windy and was a quiet day. However, the day DM and EHT minaret was measured was windy. So the amplitude of EHT minaret was ten times or more compared with that of WHT minaret. Therefore, neither 0.8 Hz vibration of Suleymaniye mosque nor 1.2Hz vibration of Sehzade mosque was transmitted from the foundation; it is speculated that minarets were excited by the wind and then the vibration was transmitted to the main dome.

At the time of the Kocaeli Earthquake, maximum PGA in Istanbul for hard rock site was only 41 Gal at YPK station. It is interesting to occur the shift of the natural frequency under such a weak seismic motion. Before and after the earthquake, the transfer functions kept their shapes as shown in Figure 8, but the peak frequency has slightly shifted to lower, except the lowest peak frequency seen in Suleymaniye and Sehzade mosques.

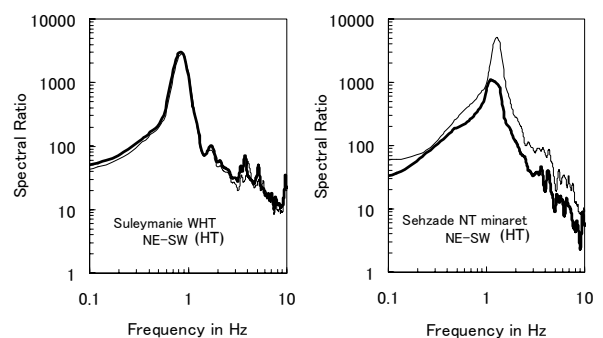
Figure 9. Examples of Estimated Transfer Function of Minaret

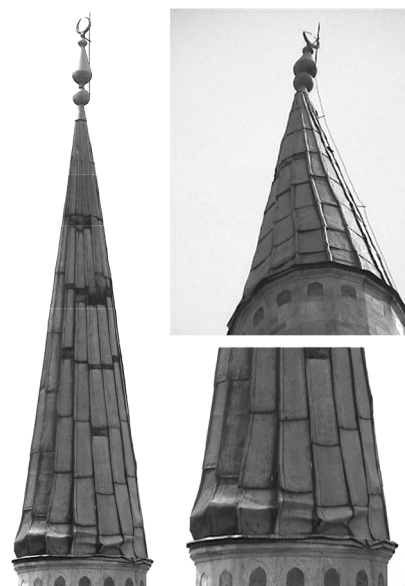
However, it is thought that the minarets themselves vibrated quite intensely during the earthquake. Especially in the case of WHT minaret of Suleymaniye mosque, damage as shown in Figure 10 has appeared in incidental facilities such as a roof. That is, buckling arise in the west side of a lower part of a conic roof, and the ornament at the top of the conic roof is crooked on the east side.

Figure 10. Damage of WHT minaret of Suleymaniye Mosque

The shift of the natural frequency for WHT minaret is larger than others. As a result, the shift rate of the natural frequency correspond to the damage grade of incidental facilities. Hereafter, the measurement result for every structure is examined.

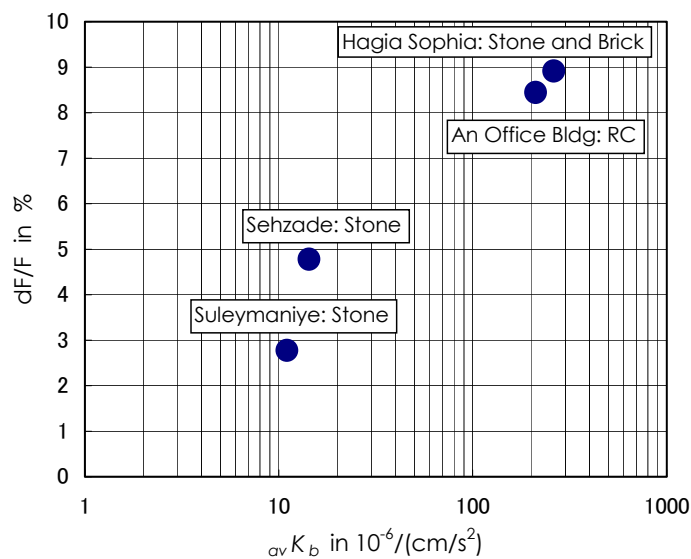
Figure 11. Relationship between  ${}_aK_b$  and  $dF/F$  for Measured Structures

Natural frequency shift can be considered as an expression of the degree of damage. Figure 11 shows the relationship between  ${}_aK_b$  value and the rate of natural frequency shift. The relation between  ${}_aK_b$  and the frequency shift rate suggests that  ${}_aK_b$  can be given as damage degree before the earthquake.

Figure 11 shows large  ${}_aK_b$  correspond to larger damage in general. Both Suleymaniye and Sehzade mosque have the same type of structure, and Hagia Sophia museum has a structure type of similar to them. On the other hand, the office building has different characteristics as RC structure.

In addition, the  ${}_aK_b$  value for an office building was examined using the EW direction considered to reflect the rigidity of the building itself.
