THE CHANGE OF THE DYNAMIC CHARACTERISTICS USING MICROTREMOR

Tsutomu Sato¹, Yutaka Nakamura^{1,2}, Jun Saita¹

¹ System and Data Research Co., Ltd., Tokyo, Japan

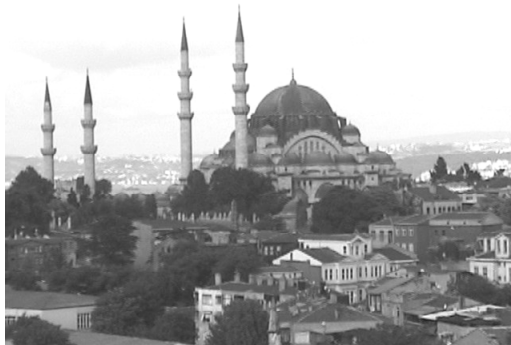
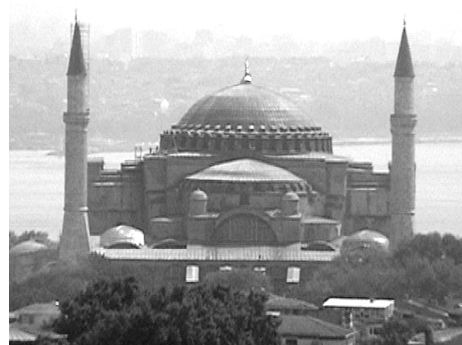
Figure 1. Overview of Measured Structures

(a) Suleymaniye Mosque

(b) Hagia Sophia Museum

(c) Sehzade Mosque

(d) An Office Building

Microtremor measurement was conducted for historical structures as Suleymaniye mosque, Hagia Sophia museum, Sehzade mosque, and newly constructed office building. Figure 1 shows the overview of these structures. Figures 2 to 5 show the floor plan and elevation with measurement points, and Table 1 shows the detail of the structures such as height, structural type, established year and the date of measurement.

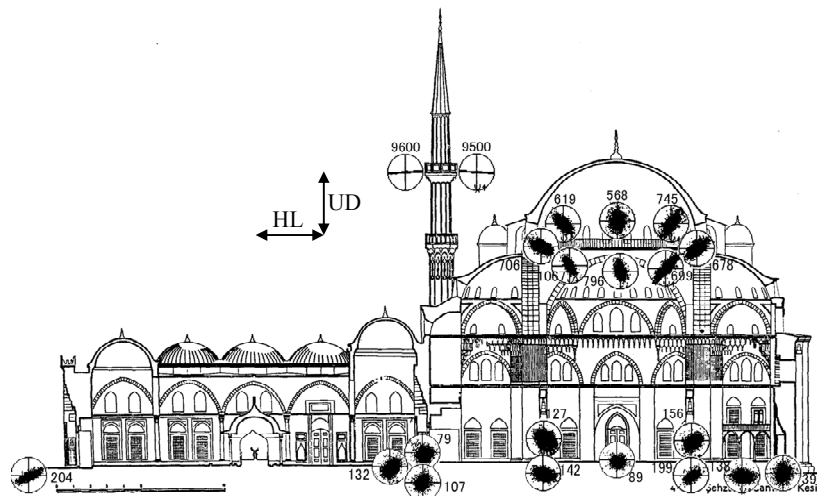
Figure 7. Normalized Loci of Microtremors in HL-UD Plane for 40.96 second at each Measurement Points of Sehzade Mosque (non-simultaneous measurement). Dots in circle indicate the normalized locus, and the number near the circle means maximum value of microtremor in unit of 10^{-8} m/s.

the locus of microtremor for 40.96 seconds in the circle to the position corresponding to every measurement point, and the number near the circle means maximum amplitude in 10^{-8} m/s. This figure shows that minarets are vibrating more intensely than the structures. The state of the vibration for main dome can also be grasped by this figure.

Figure 7 shows the velocity loci of microtremor at every measurement point on Sehzade mosque. It shows
