# VULNERABILITY INVESTIGATION OF ROMAN COLOSSEUM USING MICROTREMOR

# SUMMERY

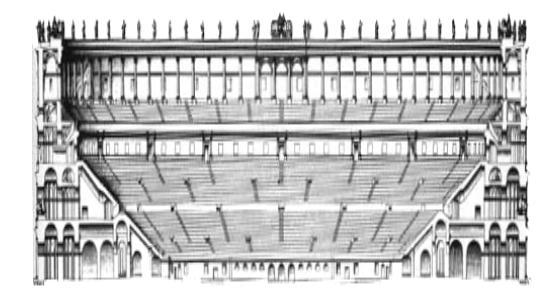
Figure 2: NS cross-section across the central axis of Colosseum.

From AD 75 to AD 80, Colosseum's construction took just 5 years to complete. It can be considered as an architectural wonder especially with its extraordinary dimension. It has an elliptical plan with a circumference of 537m, the major axis of its ellipse is 188m long, the minor axis attains 156m, and the walls in the outer ring rise to almost 50m above ground. Cross section is given in Figure 2.

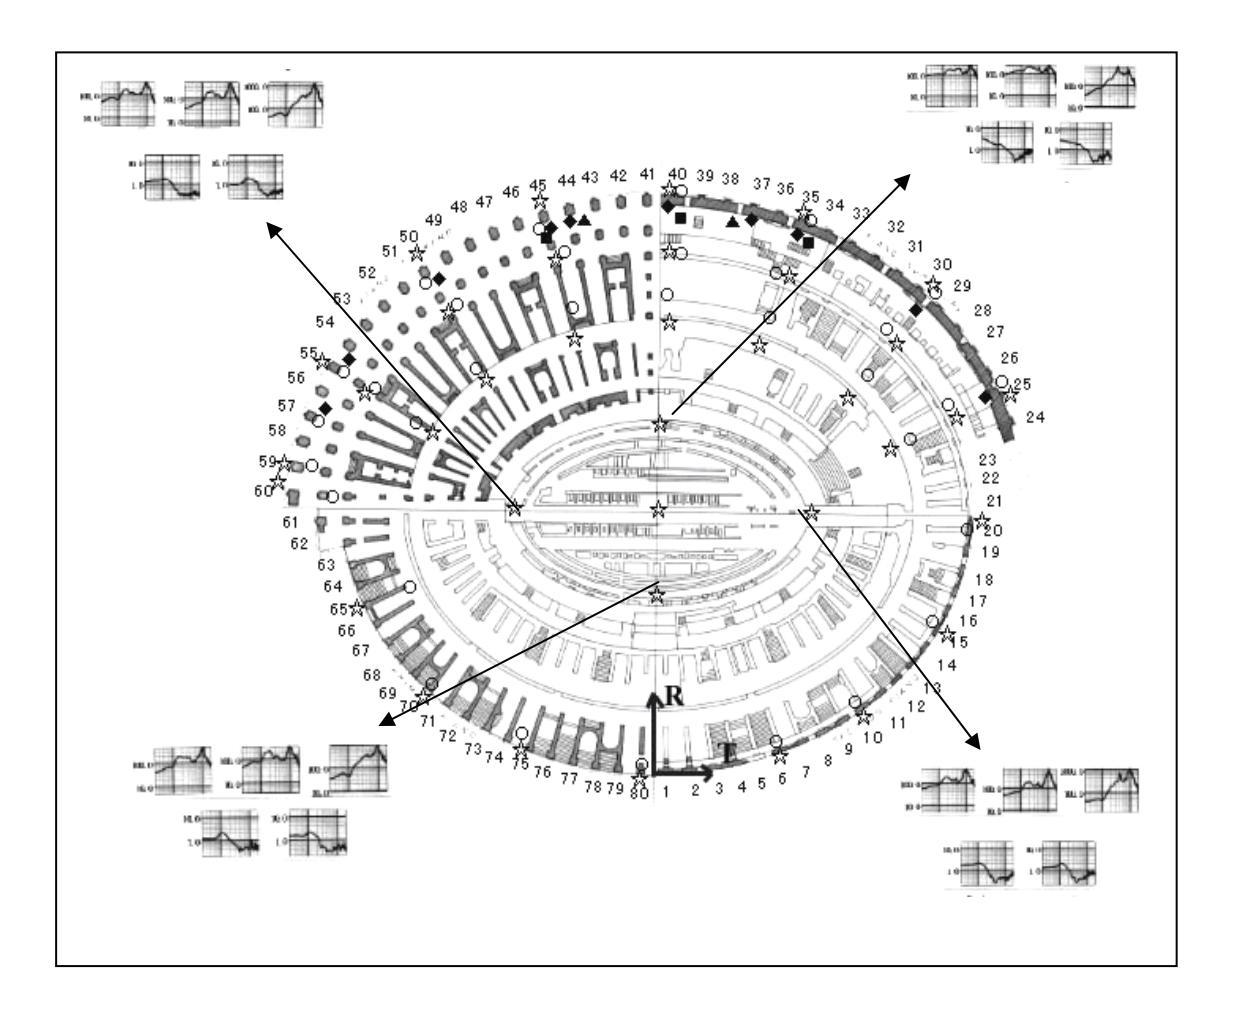
Figure 4: Location of measurements at ground,  $1^{st}$ ,  $2^{nd}$ ,  $3^{rd}$ ,  $4^{th}$  floors are shown with  $\not\approx, O, \blacklozenge, \blacksquare, \blacktriangle$ , respectively. Spectrums shows the QTS results of basement floor measurements.

QTS spectrums (Nakamura, 1989) at basement level are given in Figure 4 together with measurement point locations. On west, south, east side of the basement, there is a peak around 1.2Hz with the amplification factor of 1.5, but these peaks are not so reliable and especially on the north side is not so clear probably because of the effect of the structure and traffic noise around this part. Effects of Rayleigh waves are clear at all points.

As we can follow, there are no peaks for the points from 6 to 25 (location of these points are shown in Figure 4). For both first and second floor levels, 1.5Hz peak with amplification factor about 4.5 in radial (R) and 3.5 in transversal (T) direction starts from the point 25 on the outer wall. This point is the one which is connected with the supporting triangular wall. Peaks continue till point 60 which outer wall ends. Amplification is high along the radial direction for many points of outer wall. This can be concluded as 1.5Hz vibration is caused by the effect of outer wall. Similarly Figure 8 shows distribution of A for about 3Hz. For the first floor, amplification factor having the value of 13 in radial component is high especially for the beginning and the ending points of the outer wall which starts from 25 and continues till 60. There are no strongly amplified points at upper floor levels for this frequency.

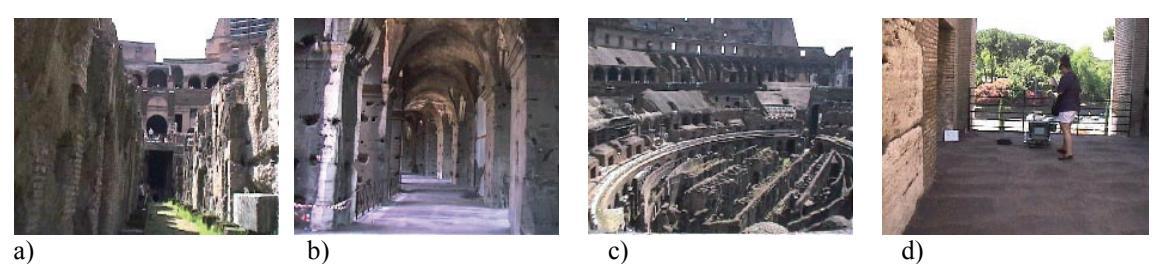
Figure 5: Views from measurement area, View from a) basement, b) 2<sup>nd</sup> floor c) 4<sup>th</sup> floor, d) Measurement at second floor.

**Measurement:** An instrument named Portable Intelligent Collector (PIC) was used for microtremor measurements. PIC includes two sensors, connection cables, main body installed in a metal case that contains A/D converter, portable computer and amplifiers. Three components (two horizontal and one vertical) of microtremor are recorded at every measurement points. Sampling interval is 1/100 sec and the length of each record is 40.96 sec. Measurement was repeated three times at each observation point. Figure 4 shows the location of measurements at ground, 1<sup>st</sup>, 2<sup>nd</sup>, 3<sup>rd</sup>,4<sup>th</sup> floors. And figure 5. shows some

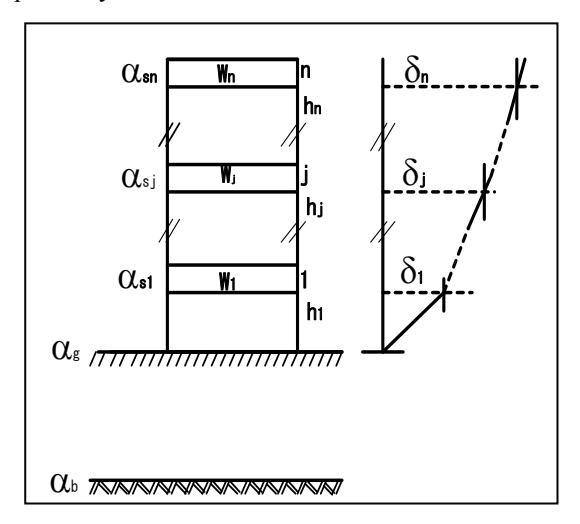
Figure 6: Derivation of mode shapes of  $n^{th}$  floor structures.  $\delta_j$  is the horizontal displacement, W is the weight of the  $j^{th}$  floor,  $h_j$  is the height of  $j^{th}$ column,  $\alpha_b$ ,  $\alpha_g$ ,  $\alpha_{sj}$  are the horizontal acceleration of the basement, ground surface and  $j^{th}$  floor of the structure, respectively. If unit of drift angle  $\gamma_j$  is 10<sup>-6</sup>,  $h_j$  is meter and seismic acceleration is measured in unit Gal (cm/sec<sup>2</sup>), than with the unit adjustment, equation (2) can be written in following form,

**Deformation of Structures During Earthquakes and Vulnerability Index (K values) for Structures:** Deformation of structures are related with seismic motion of the basement, dynamic characteristics of surface layer and structures. And to estimate possible damage for the future earthquakes, it is important to know the present durability condition of the ground and structure correctly. For this vulnerable weak points of the structures should be investigated in advance. Figure (6) simply shows the mode shape and deformation characteristics of n<sup>th</sup> floor structure.

Horizontal displacement  $\delta_i$  shown in Figure 5.can be written as in equation (1),

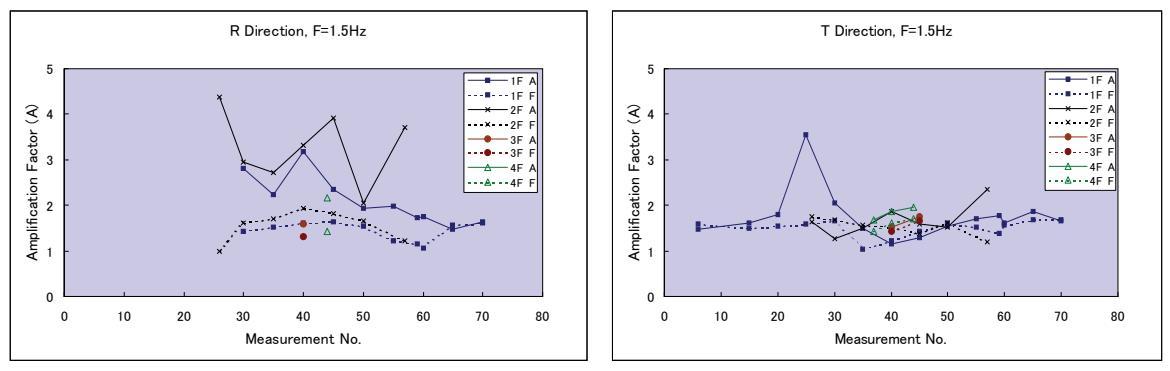
Figure 7: Distribution of amplification factor for R and T directions for F=1.5 Hz frequency.

Amplification in radial direction for the first floor is about three times bigger than the transversal direction for point 25 and 60. This can be concluded as, structure is weak for the effects coming from the radial direction. Although triangularly shaped supporting wall supports the system in transversal direction, the wall is weak to the motion at radial direction. Figure 9 shows that at 4.5Hz in radial direction, amplification on the first floor level is high at points 15, 25 and especially at 70 having a value of 16. Amplification at this frequency for the upper floor levels is small.

From spectral ratios of each points, where measurements were done simultaneously, different peaks caused by different modes of the structure were found. Figure 7 shows the distribution of Amplification factor (A) for simultaneously measured points at ground and upper floor levels at 1.5 Hz frequency.

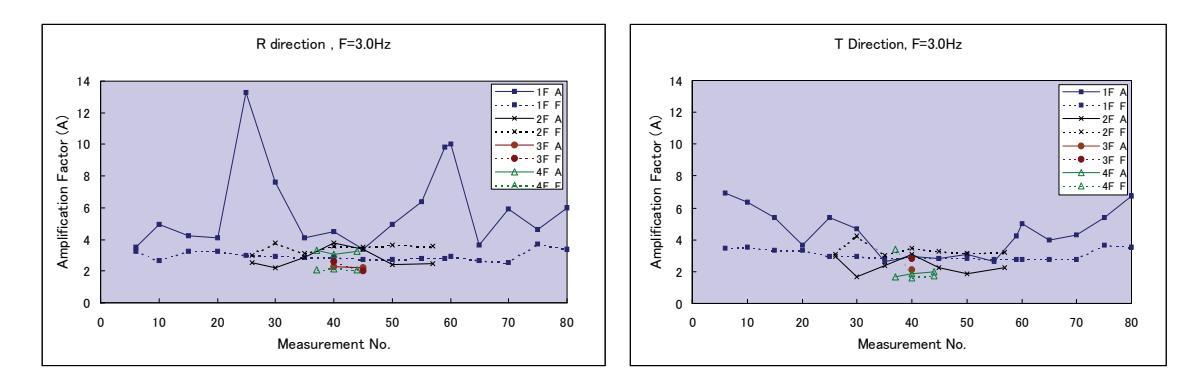
Figure 8: Distribution of amplification factor for R and T directions for F=3.0 Hz frequency.

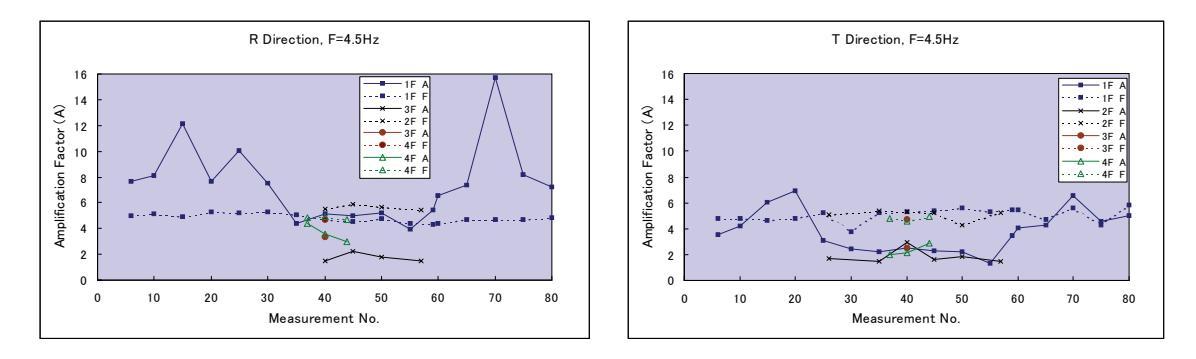
Figure 9: Distribution of amplification factor for R and T directions for F=4.5 Hz frequency.

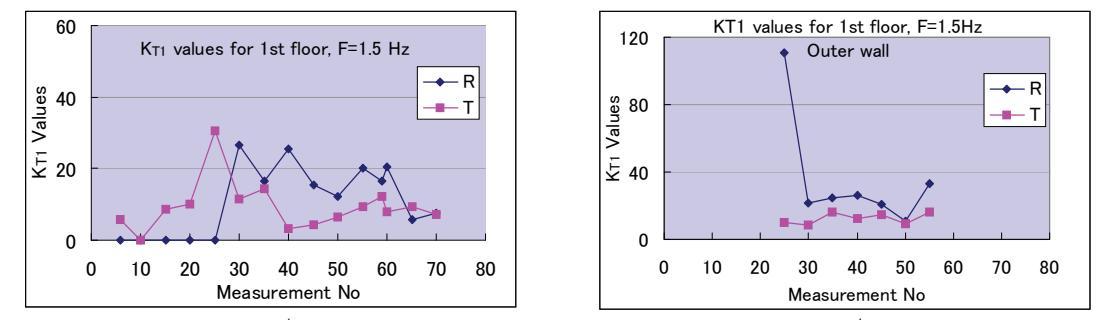
Vulnerability index,  $K_{Tj}$  values are also calculated from the equation (6). Figure 10 shows the distribution of  $K_{T1}$  values on the first floor at inner wall through the whole ring, for 1.5Hz. This distribution shows the vulnerable points. High K values at points 25, 30, 40, 55, 60 in figure 10, also shows that these points have higher risk of damage for inner wall. Figure 11 shows  $K_{T1}$  values again for the first floor but outer. In outer wall, having a value of 110, K value is extremely high at point 25 showing the weakness of this point. Similarly figure 12 shows the distribution of  $K_{T2}$  values for second floor for 1.5Hz. At this figure, points 26 and 59 have K value as 150 and 60 respectively, again showing the high risks at these points.  $K_{Tj}$  values are also calculated for 3.0 Hz. frequency and shown in figure 13, 14 and figure 15 for first and second and fourth floor levels, respectively. Similar with 1.5 Hz frequency, figure 14 shows high values of K at points 25 and 59. In figure 15, K values are not high for second floor, comparing with 1.5Hz frequency. And finally Figure 15 shows  $K_{T4}$  values for 3.0Hz. At this level, point 40 has higher risk than the other points.

Figure 10: K<sub>T1</sub> values for 1<sup>st</sup> floor level, F=1.5Hz Figure 11: K<sub>T1</sub> values for 1<sup>st</sup> floor, F=1.5 Hz.

Maximum acceptable accelerations for vulnerable points mentioned above are also calculated from equation (7). Calculation was made for 1.5Hz and 3 Hz for the points where calculated K values are very high. These are 25 and 59 for both first and second floor levels.  $K_{T1}$  value for point 30 for 1.5 Hz is about 29 and  $\gamma_{aj}$  is taken as 1/200. Then from equation (7) maximum acceptable acceleration is about 172Gal for this point of outer wall. And for 3.0 Hz for the same point,  $K_{T1}$  is about 25 and maximum acceleration is calculated as 200Gal. These values are checked with the conditions caused by 1349 earthquake. For 1349 earthquake the reported modified Mercalli intensity is VIII which correspond to an acceleration of 175 Gal. The calculated maximum acceptable acceleration for point 60 gives 238Gal for 1.5 Hz and 151Gal for 3.0Hz.  $K_{T2}$  values at second floor level for point 25 and 59 are 142 and 59 respectively for radial direction. Maximum accelerations at these points for 1.5Hz are 35Gal and 85 Gal, and for 3.0Hz 119Gal and 147Gal, respectively. These values show that, MM VI-VII earthquake which correspond to acceleration about 67Gal will be enough to cause more damage in vulnerable points of Colosseum.

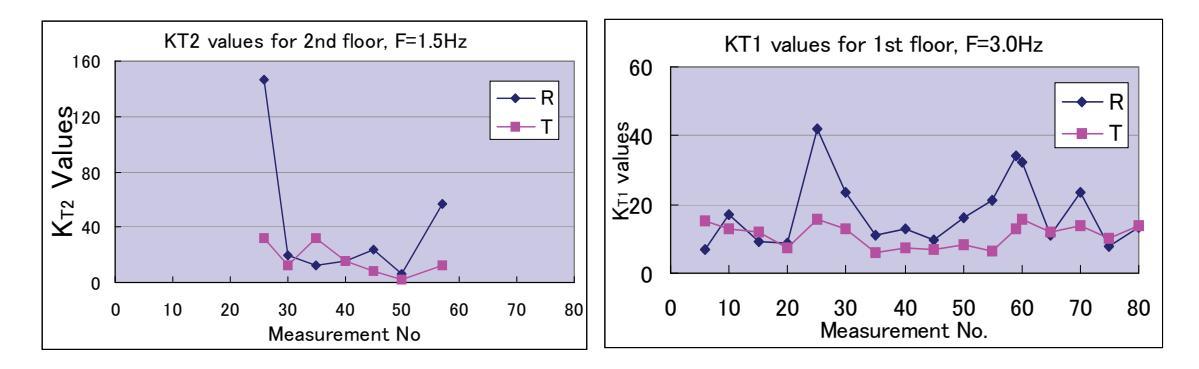
Figure 12: K<sub>T2</sub> values for 2<sup>nd</sup> floor level, F=1.5 Hz Figure 13: K<sub>T1</sub> values for 1<sup>st</sup> floor level, F=3.0Hz

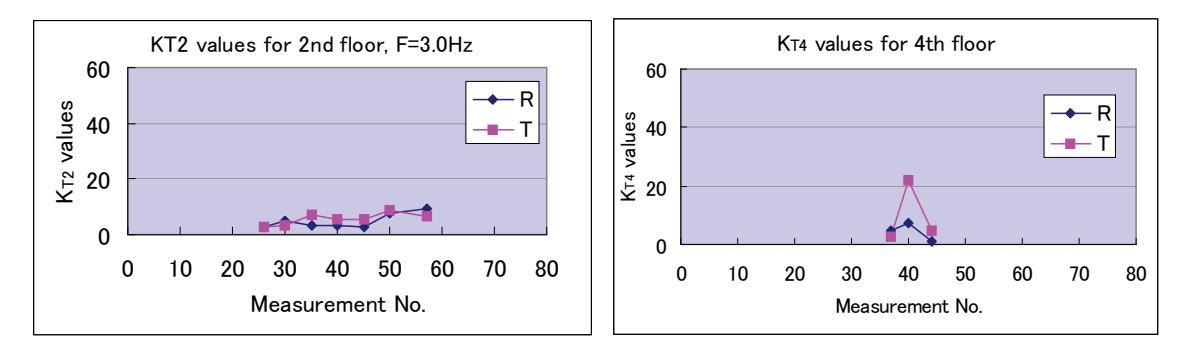
Figure 14: KT2 values for 2<sup>nd</sup> floor, F=3.0Hz

Figure 15: KT4 values for 4<sup>th</sup> floor, F=3.0Hz.

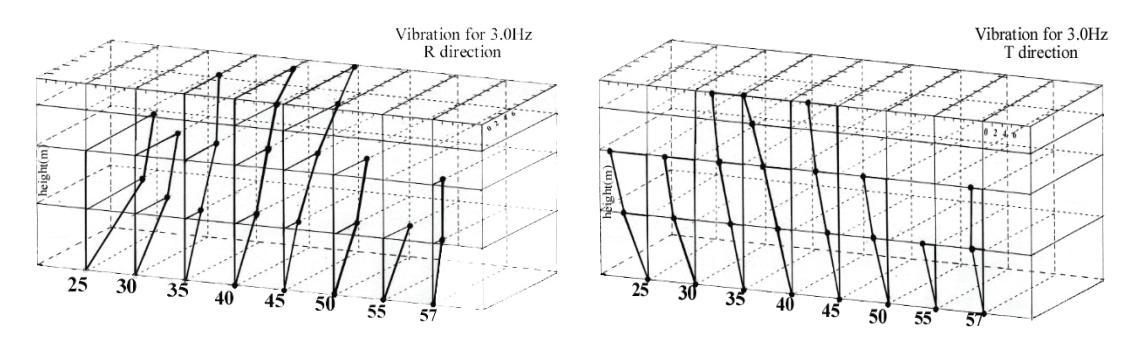
Figure 17: Vibration mode for 3.0Hz, from point 25 to point 57. R direction(left) and T direction (right)
