## Preliminary Report of Microtremor Measurement on Tlateloco Tamaulipas

Date of measurement : November 19<sup>th</sup>, 2000

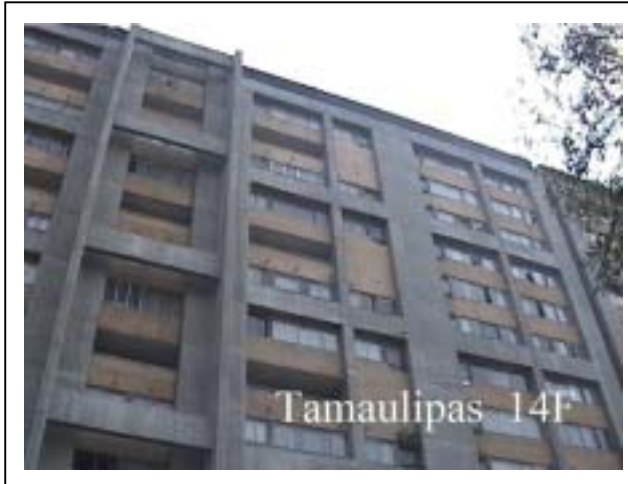
Fig.1 External appearance of measured building

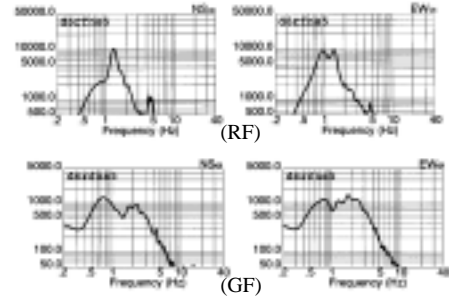
- Fourier Spectrum of North Point -

<b>Predominant Frequencies</b>	
Statistic value	
$F = (10 \sim 16)/N$	
$= 0.71 \sim 1.14(\text{Hz})$	
Measured value	
NS component	F=1.36(Hz)
EW component	F=1.06(Hz)
F: Frequency (Hz)	
N: Number of stories (Floor)

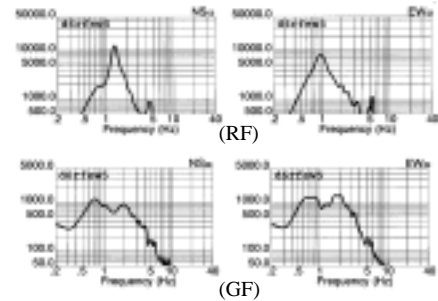
- Fourier Spectrum of East Point -

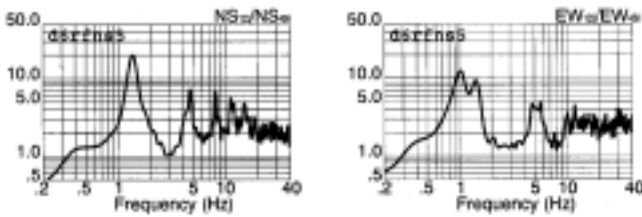
Fig.2 Estimated quasi-transfer spectrum of north point on the roof

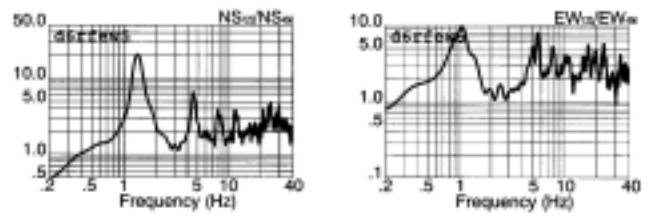
Fig.3 Estimated quasi-transfer spectrum of east point on the roof

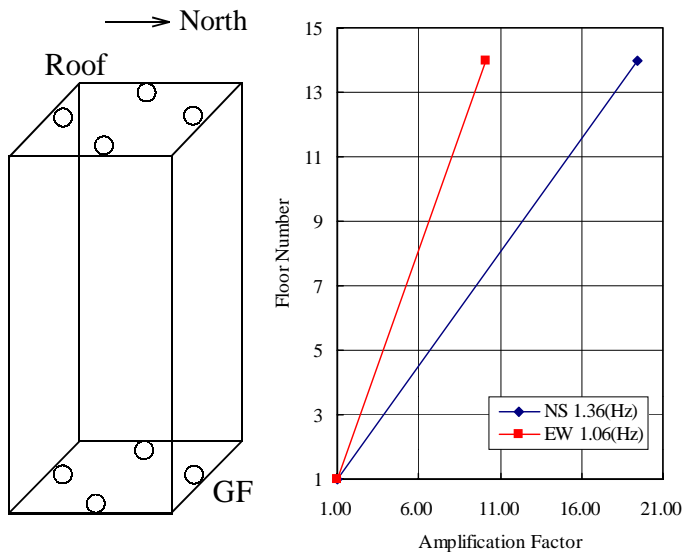
Fig.4 Measured points on each floor and vibration mode
