## コロッセオの地震観測加速度データから算定した積分変位による動画

中村 豊 (SDR)

2022年10月11日

# On a video movie of displacement derived from integration of seismic acceleration data at Colosseum

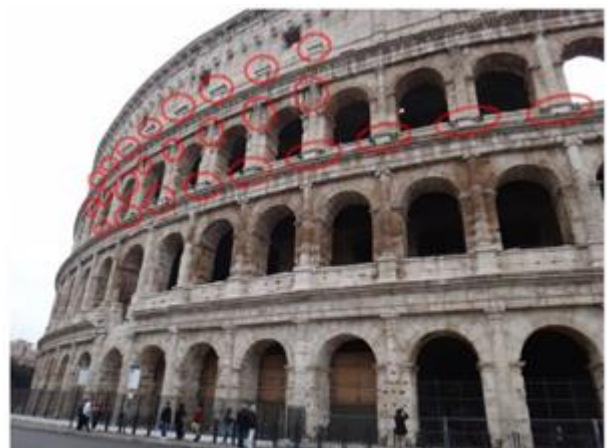
図 #40周辺に設置されたファスナー(赤丸内)  
Figure: Fasteners around #40

#40 の動きが自然であるのに対し、#51 の動きがぎこちないのは、#40 周辺に設置されたファスナーの効果を示すものかもしれない。また、GF と 1F の間の R 方向は #40 が柱のみであるのに対し #51 では壁が含まれているために、その剛性は #51 の方が大きく屈曲しにくいと考えられる。このほか、#40 と #51 の動きの相違は、石積みの状況を反映しているものと考えられ、この分析のように変位挙動を把握することが健全性を分析する有力な手段となる可能性がある。(以上)

The natural movement of #40 while the movement of #51 is unnatural may show an effect of the fasteners installed around #40. The stiffness in the R direction between GF and 1F is greater in #51 due to the inclusion of walls in #51, whereas #40 has only a pillar, and #51 is less likely to bend. In addition, the difference in movement between #40 and #51 may reflect the condition of the masonry, and understanding the behavior of displacement, as in this analysis, may be a powerful tool for analyzing the health of the structure. (end of text)
